# **An Investigation into Ultrasonic Cleaning Historic Textiles**

Megan Mary Creamer

Submitted in partial fulfilment of the requirements for the Degree of Master of Philosophy in  
Textile Conservation in the School of Culture and Creative Arts, University of Glasgow,  
17 August 2018

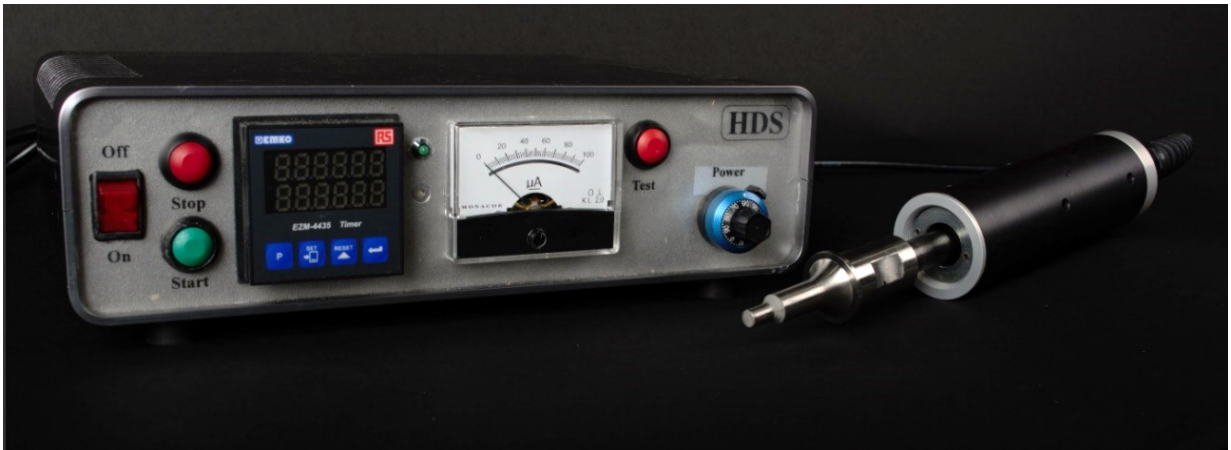
The experimental ultrasonic device used in this dissertation was developed at the British engineering company HDS Ultrasonics Ltd., London by Harry Singh. The device was loaned by V&A for this research (*Figure 8*).

*Figure 8 Ultrasonic device loaned from the V&A, designed and produced by HDS Ultrasonics Ltd.*

The device consists of two components. A control unit contains the electromechanical components of the device (*Figure 9*), and a hand-held probe contains a piezoelectric transducer (*Figure 10*). Ultrasonic probes are also referred to as sonotrodes or horns. This probe can be used by hand, or on a fixed stand. The probe was provided with a round 5 mm diameter stainless steel, flat-bottom tip, which can be changed to other sizes and shapes by the manufacturer. The device is controlled and operated with a front panel interface. Additional features and parameters are outlined below.<sup>49</sup>

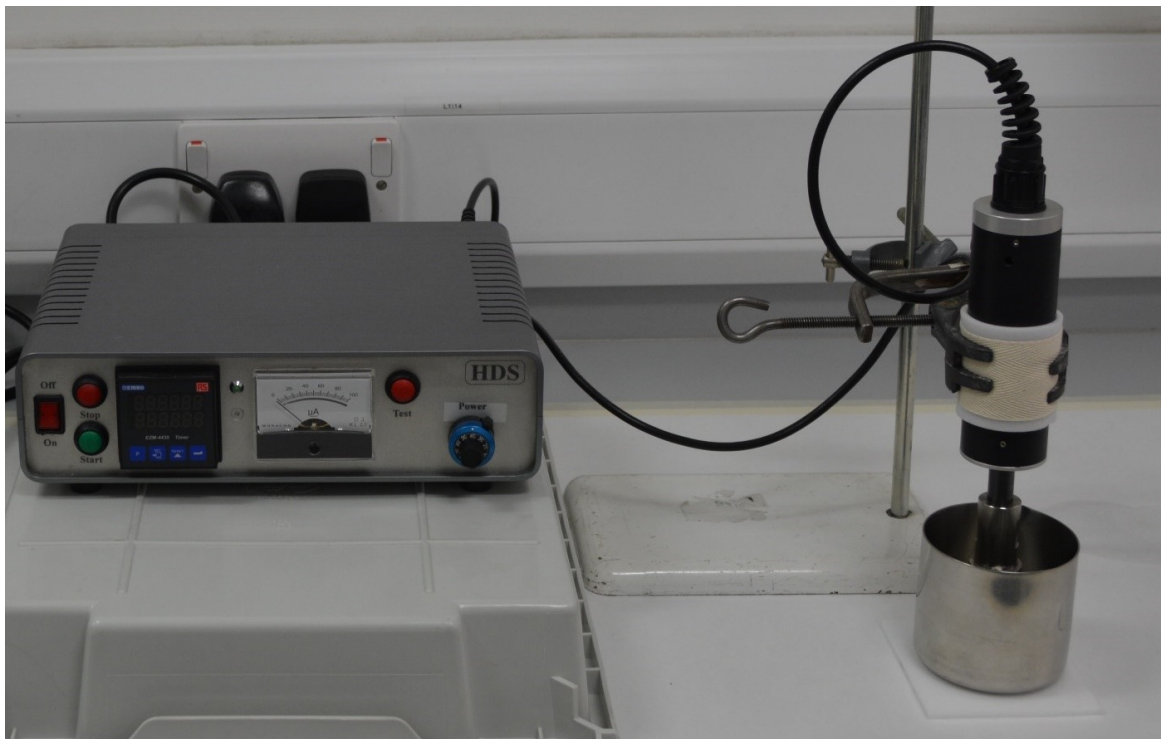
*Figure 11 Experimental testing set up.*

Experiments were carried out at fixed distances in 100 mL of solution in a stainless-steel beaker (*Figure 11*). A 30 mm circle of aluminium foil<sup>59</sup> was placed at the bottom the beaker, and then a solution was added (*Figure 12*). Ultrasound was applied for 60 seconds, and the foil was removed, labelled and evaluated. Testing parameters are outlined in *Table 1*. All testing was done at ambient conditions (18-28 °C, 30-55% relative humidity [RH]).

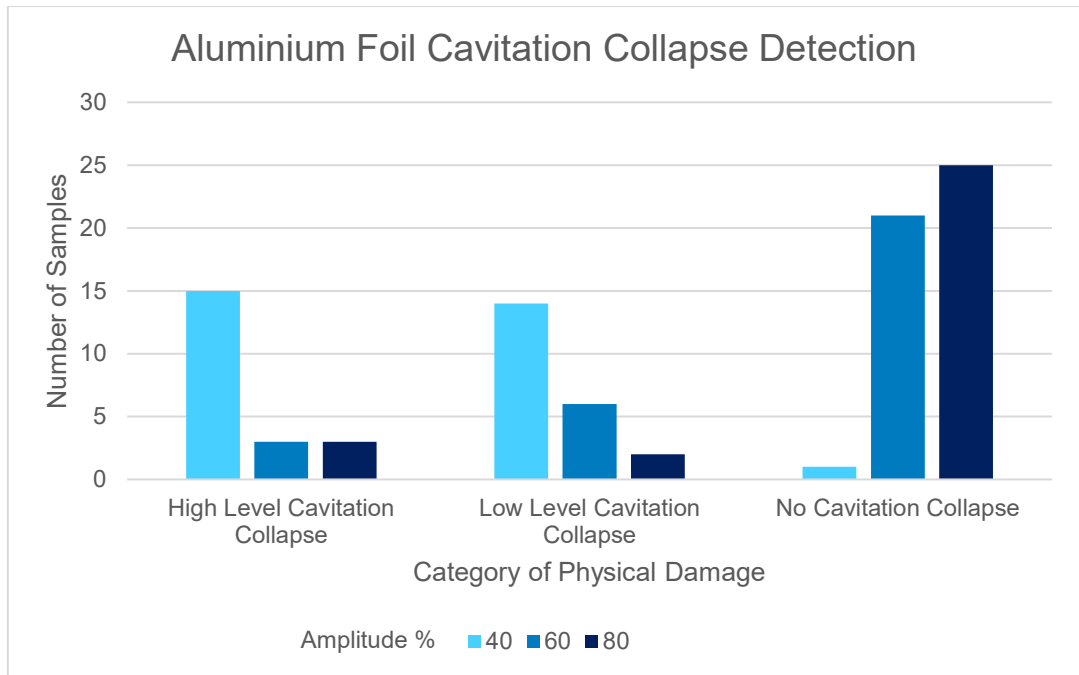
Figure 15 Chart showing overall detection of physical damage using aluminium foil according to amplitude for all six test solutions.

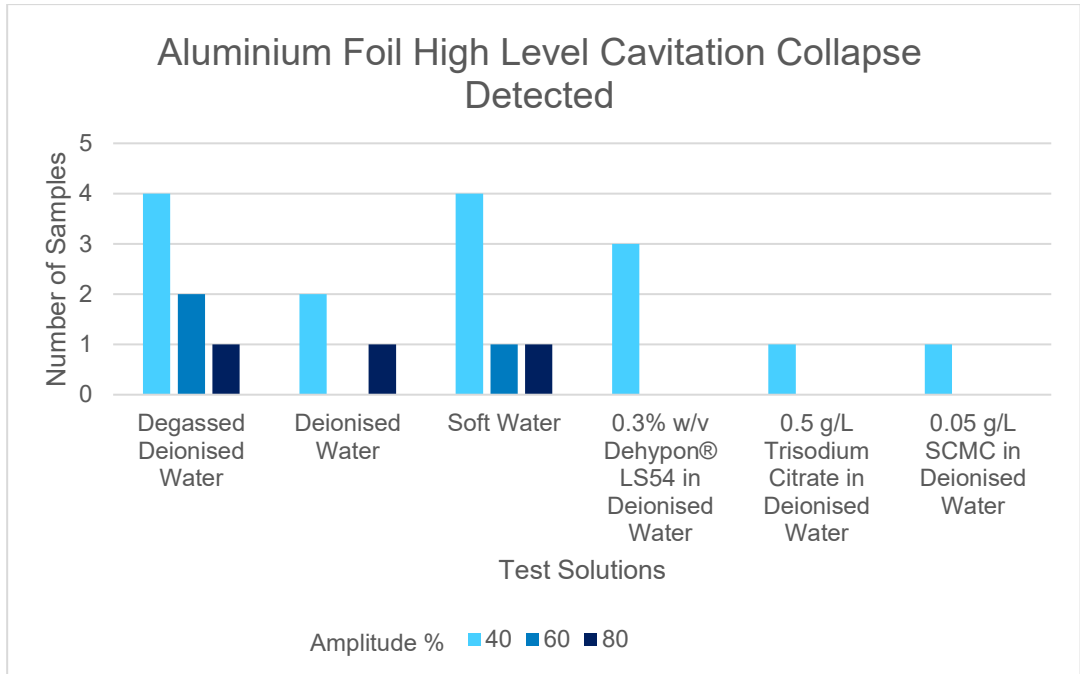
Figure 16 Chart of aluminium foil high-level cavitation collapse by solution and amplitude.

High-level cavitation collapse was defined as widespread pitting and damage across the aluminium foil, or cavitation that created holes through the aluminium in one or more locations. High-level cavitation collapse was identified in 21 samples across the six solutions (Figure 16). It was seen most frequently at 40% amplitude, and less frequently detected at 60% and 80% amplitude for all solutions. Solutions of degassed deionised water, and soft water, followed by Dehypon® LS54 had more samples with high-level cavitation collapse at 40% amplitude compared to other solutions (Figures 17, 18, 19).

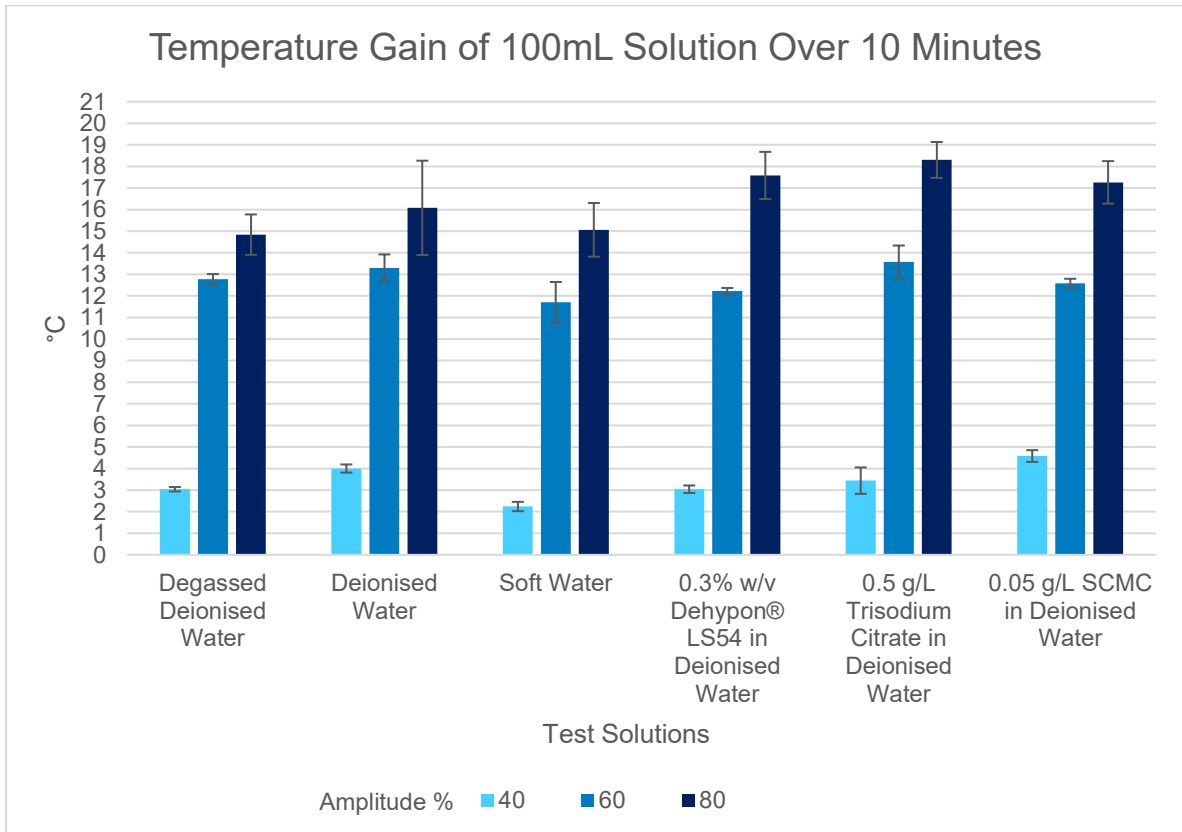
Figure 38 Chart of the averaged measurable temperature change of five replicate tests of ultrasonic exposure at 40%, 60%, and 80% amplitude for 100 mL of solution over 10 minutes.

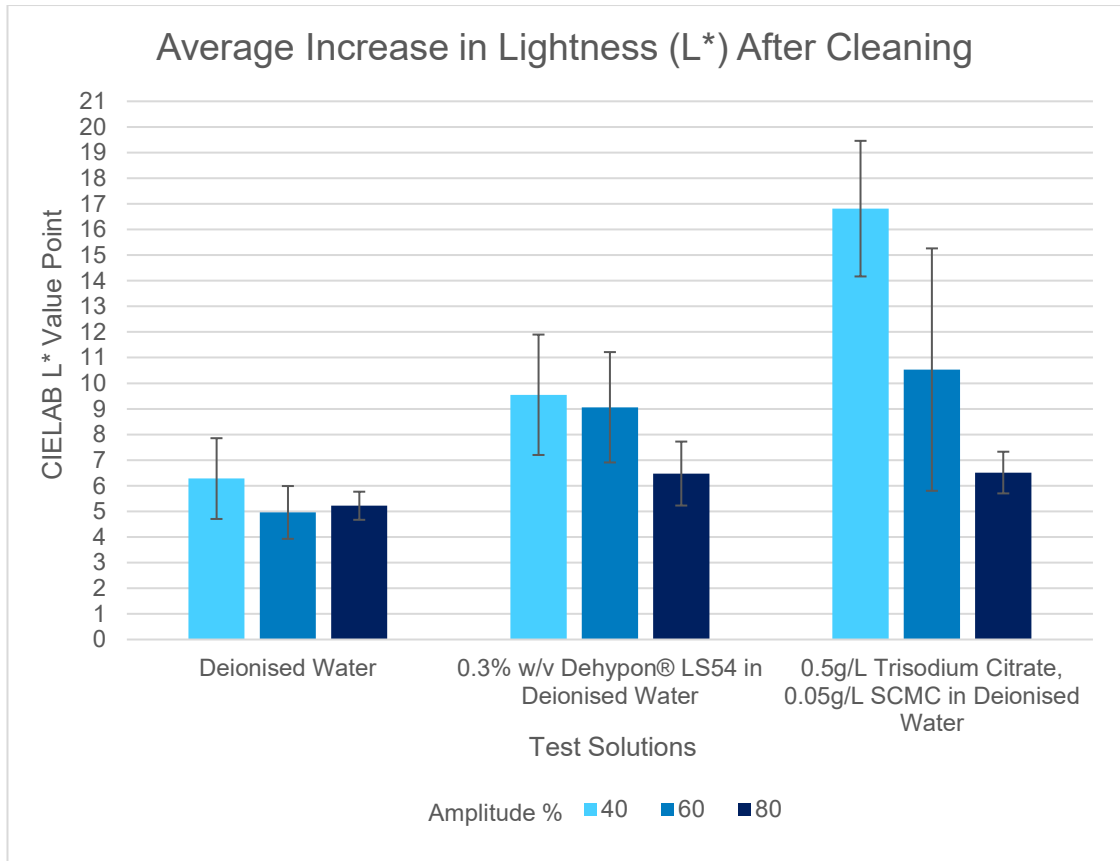
*Figure 50* Chart of average increase in brightness CIELAB  $L^*$  value after cleaning.

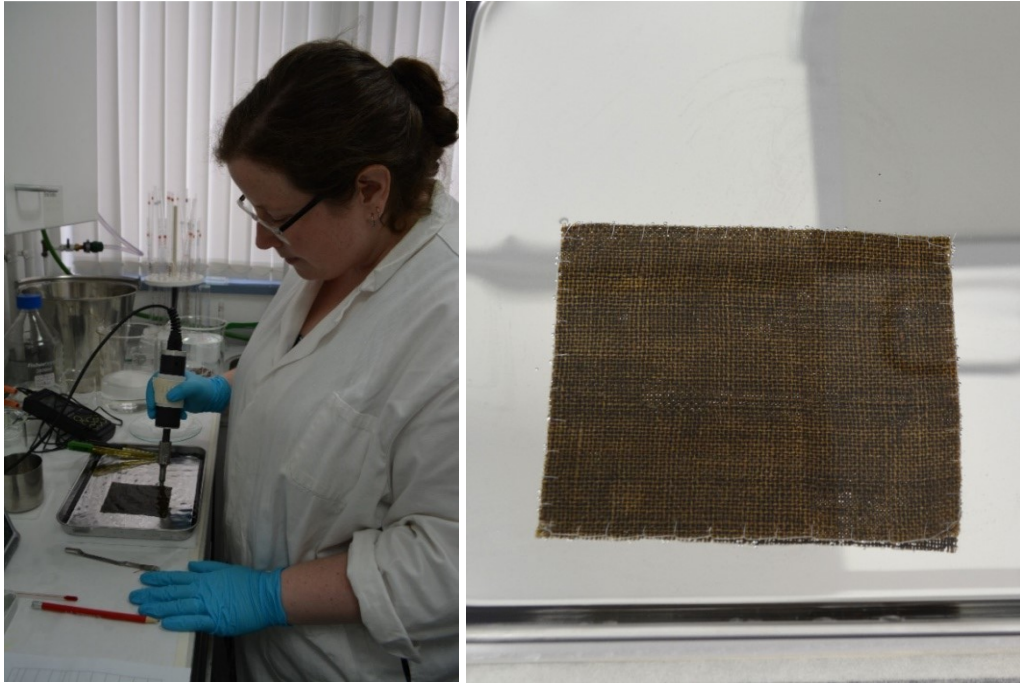
*Figure 51 Showing the wet cleaning environment and blanket stitching to secure loose areas of weave.*

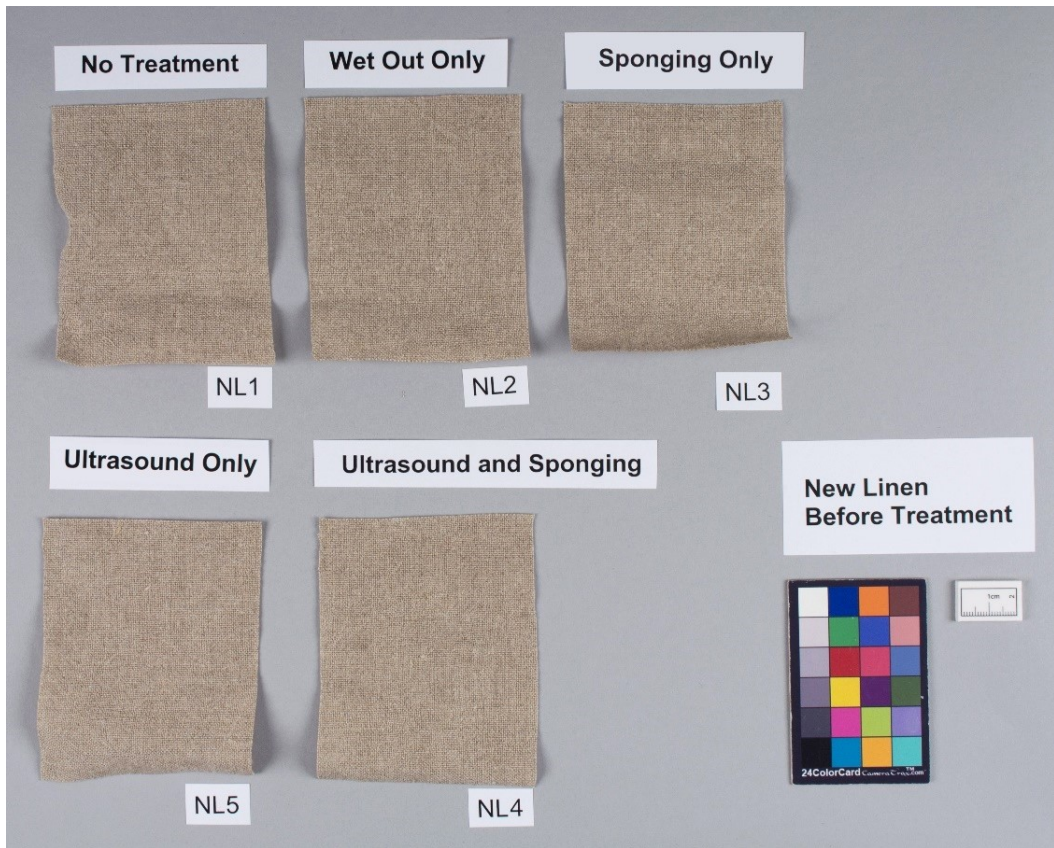
Figure 53 New linen before treatment.

Macroscopic visual analysis showed little change to the colour, brightness, or handle of the new linen from the cleaning treatments (*Figures 53, 54*). Samples of the that had mechanical action (NL3, NL4, NL5) felt hydrated and supple. Fibres were bright, shiny, and appeared clean, but not significantly different from before treatment. Little to no difference between each of these samples was seen or felt. Some wrinkling was reduced, and slight shrinkage occurred as there was no dimensional control during drying. Sample NL2 had no mechanical treatment but was wet out in each cleaning solution. This sample felt slightly stiffer and darker than before treatment. Sample NL1 had no treatment as a reference/control sample.

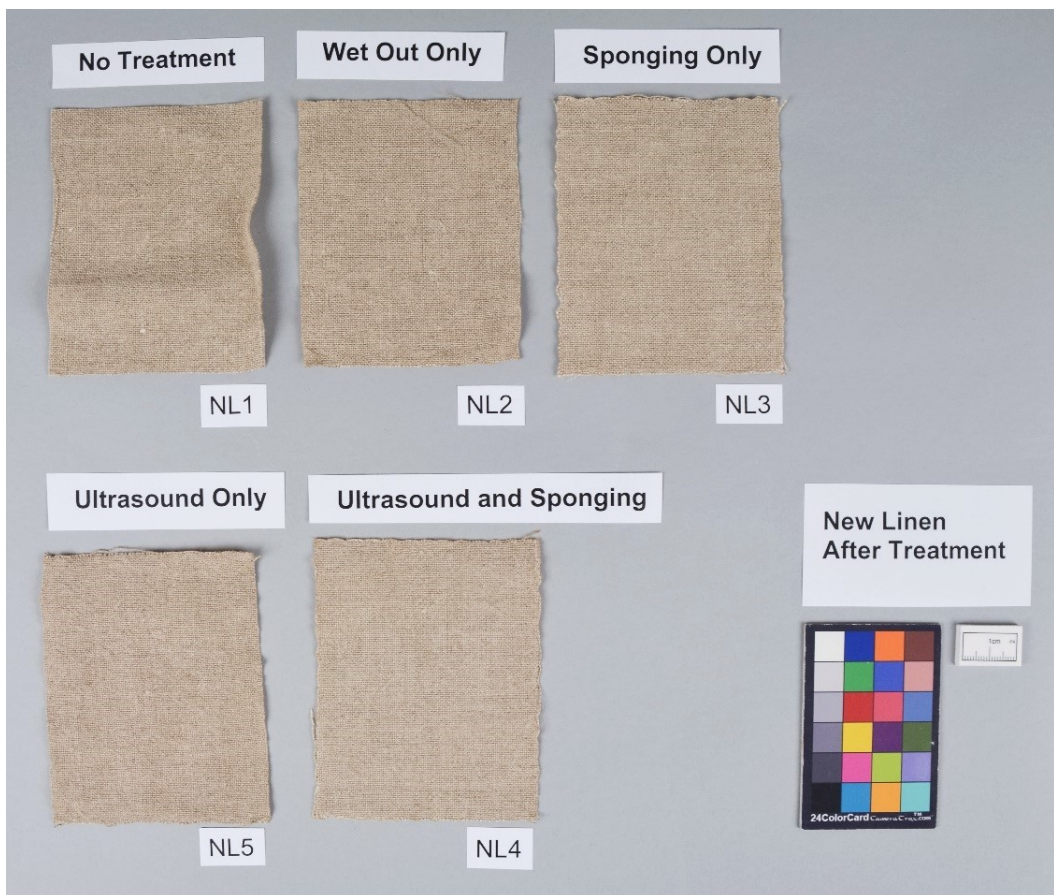
Figure 54 New linen after treatment.

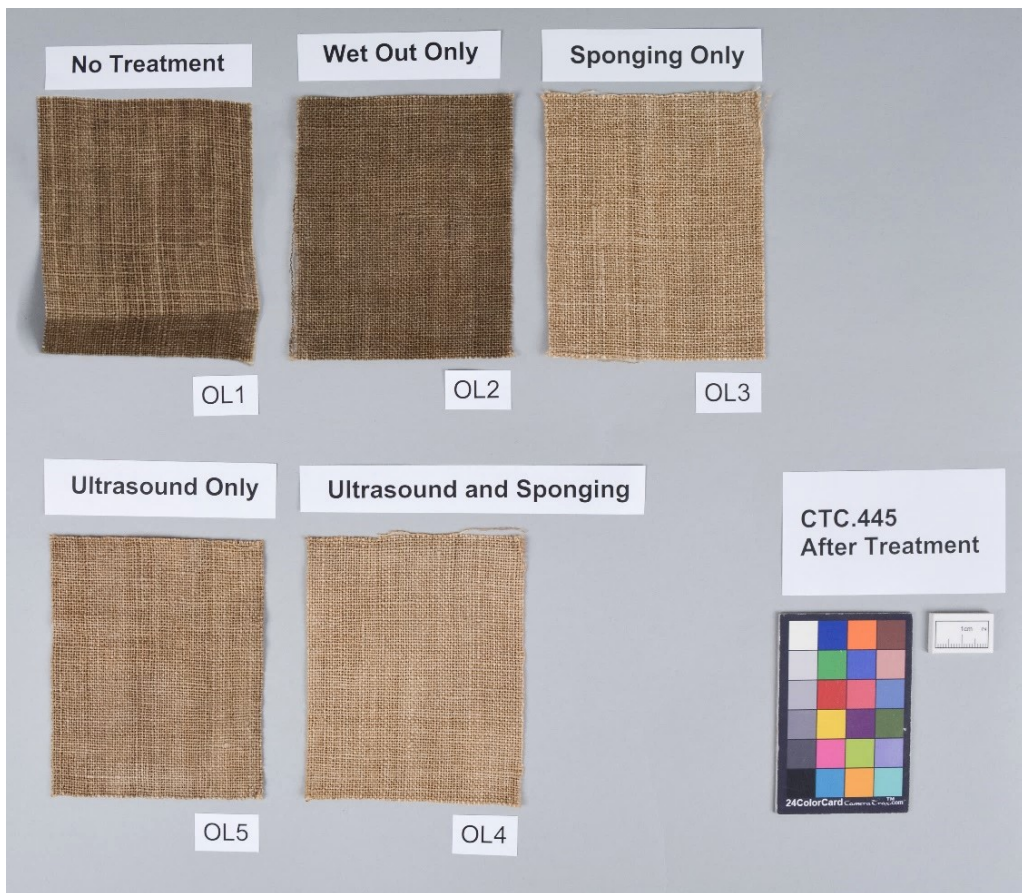
Figure 56 Historical Linen CTC.445 after treatment.

Macroscopic visual analysis of the historical linen samples showed distinctly different responses to the cleaning treatments (*Figures 55, 56*). Samples that had mechanical action (OL3, OL4, OL5) felt less brittle, and more flexible. Fine black particulate soiling was significantly reduced for all samples. There were visible differences seen between each of these samples. Some wrinkling was reduced, and no shrinkage was noted. Sample OL2 had no mechanical treatment but was wet out in each cleaning solution. This sample no longer had loose particulate soiling but was stiff and appeared slightly darker. Sample OL1 had no treatment as a reference/control sample.

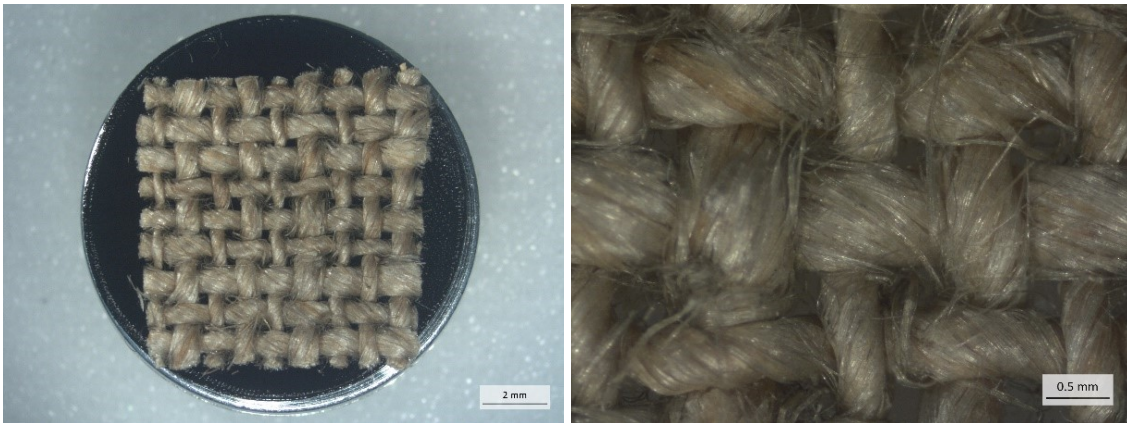
*Figure 66 Sample OL5 treated with ultrasound only, appearing slightly darker than samples OL3 or OL4.*

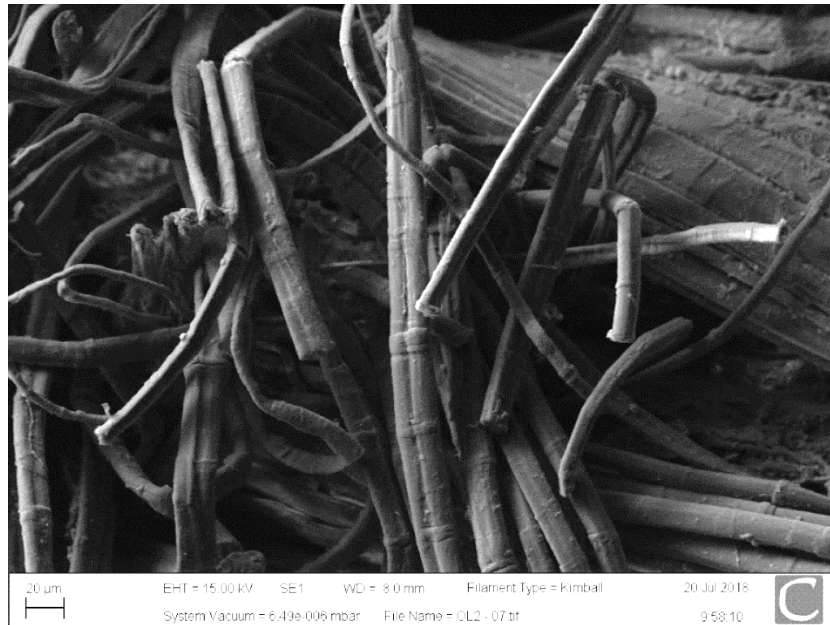
*Figure 71 Higher magnification SEM image of historic linen sample OL2 after treatment (no mechanical action).*

Closer magnification showed the fibres were still coated with fine soiling (elemental composition confirmed by EDX, discussed below). However, the surface, and condition of the linen fibres were now more visible. Surface damage showing cracks and breakage were visible in loose fibres, and on some of the surfaces (*Figures 70, 71*).

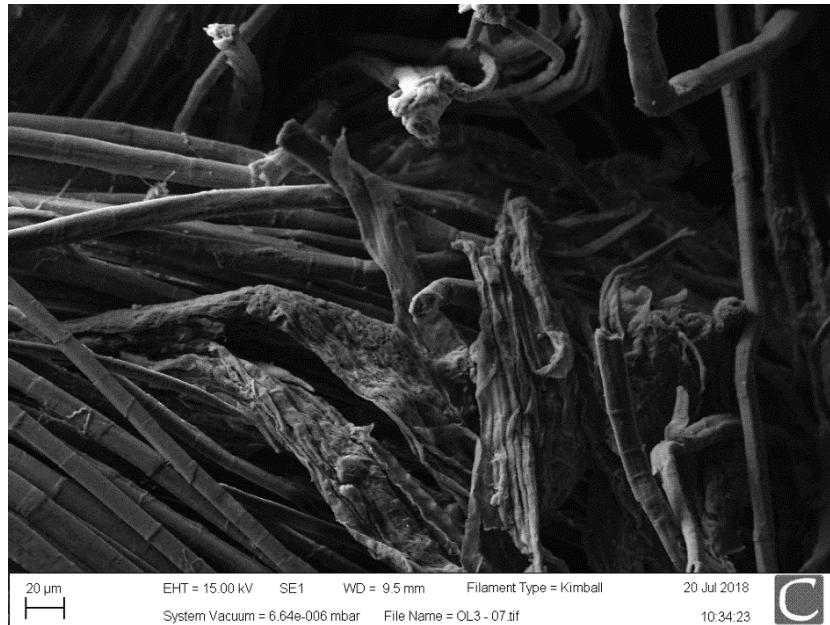
*Figure 75 Higher magnification historic linen sample OL3 focusing on damage to the fibres which was somewhat more common on this sample than others.*

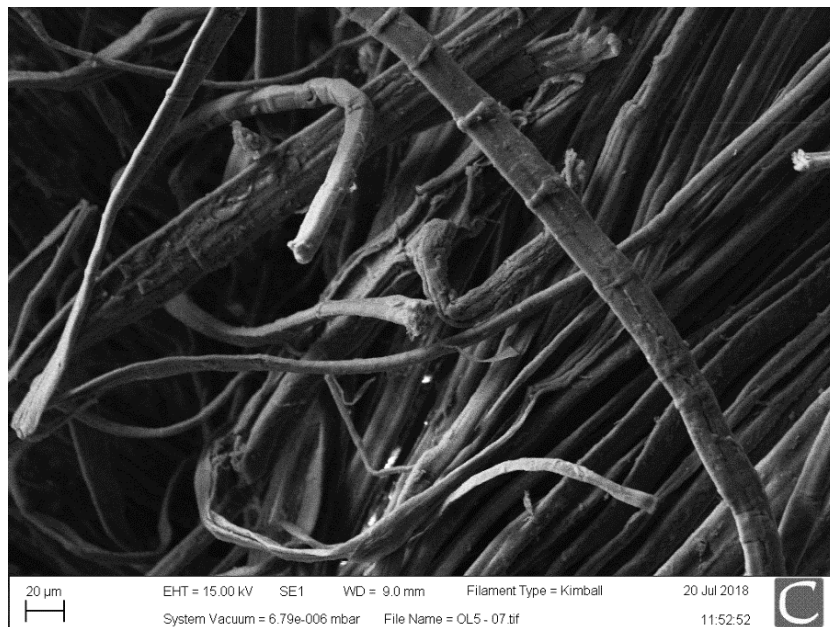
*Figure 80 Higher magnification of historic linen sample OL5. No surface soiling was visible, despite the less-bright appearance of the sample compared to the sponging-only sample OL3 or the ultrasound plus sponging sample OL4.*

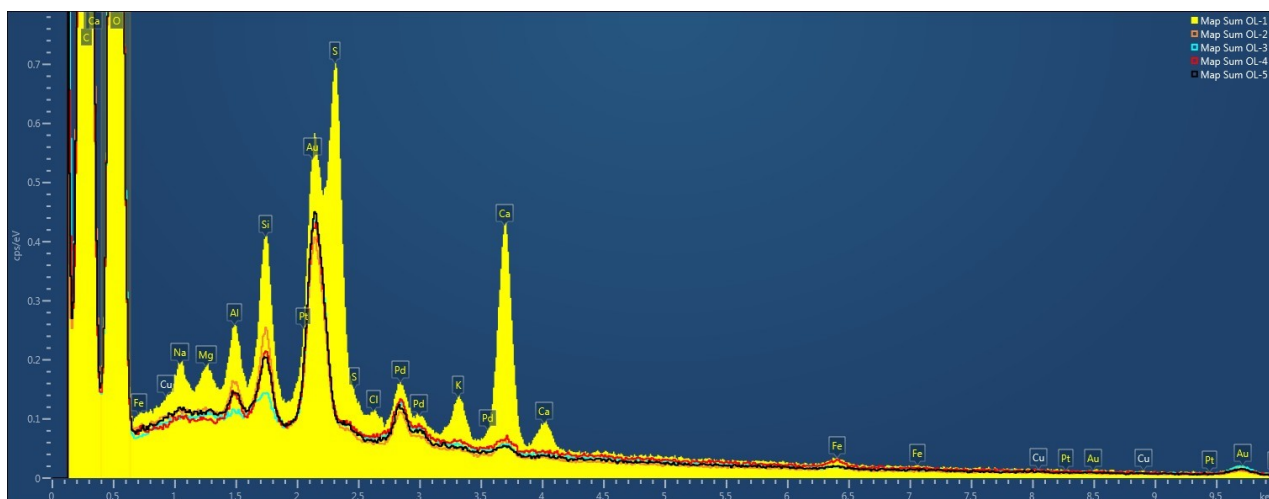
Figure 83 EDX analysis of soiling composition from each of the five historical linen samples.
